PARAJET SAFETY ADVISORY BULLETIN

APRIL 2022 - VITTORAZI MOSTER 185 PLUS AIRBOX RETAINING STRAP

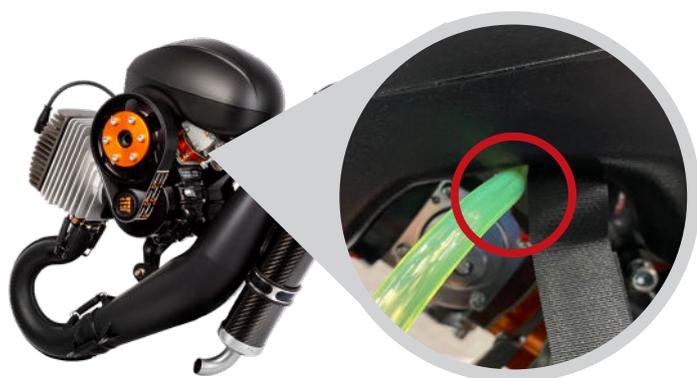
Vittorazi Moster 185 Plus MY'19, Vittorazi Moster 185 Plus MY'20 engine models on all Parajet paramotor airframes.

Parajet are aware of a small number of cases where the velcro retaining strap for the Vittorazi Moster 185 Plus airbox has caused excessive wear and a deterioration to the integrity of the inlet fuel line, as a result of prolonged engine vibration.
