# PARAJET SAFETY ADVISORY BULLETIN

## AUGUST 2020 - THROTTLE CABLE RETAINER INSTALLATION

Parajet Maverick, Parajet Zenith and Parajet Volution 3 paramotors

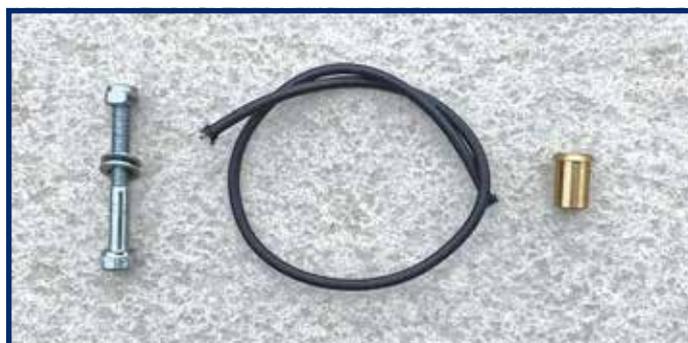
**1** Bungee Cord Retaining System Upgrade Kit

The bungee cord retaining system upgrade kit, shown above [Figure 1], should be fitted to all older Parajet models that use the now obsolete Velcro retaining strap following the installation instructions detailed in the corresponding Technical Bulletin available to download at <https://parajet.com/existing-pilots/user-manuals/>

Pilots of paramotors fitted with the now obsolete Velcro retaining strap should contact Parajet to request a bungee cord retaining system upgrade kit which will be sent out free of charge.
